4.5 ST. MARY AND HALLS COULEE SIPHONS

4.5.1 Structure Overview

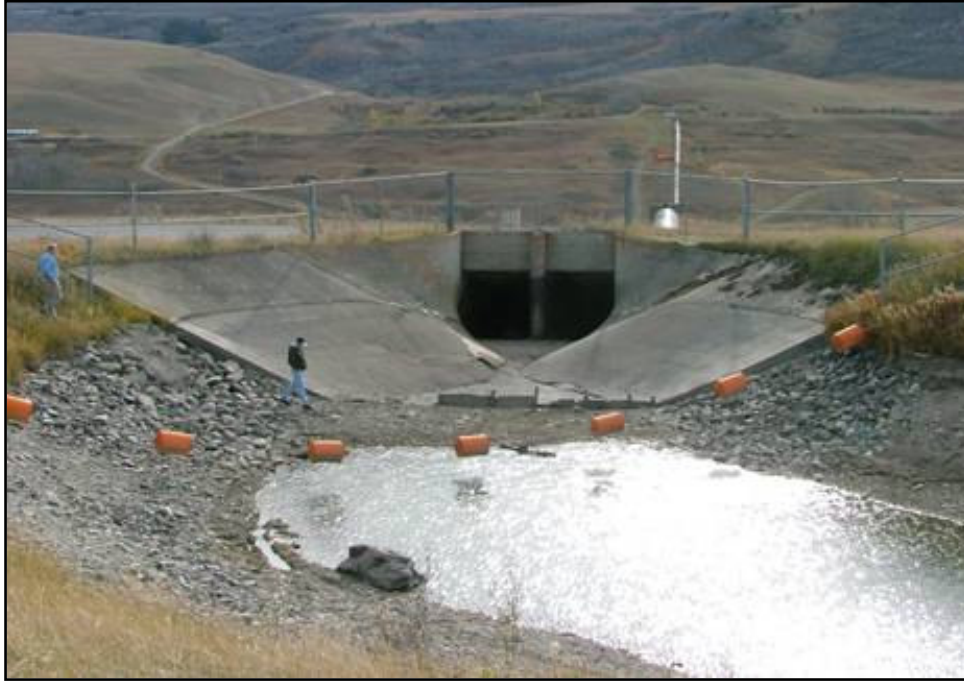
Figure 4.5.3 St. Mary River Siphon Inlet Structure (10/13/04).

- Inlet and outlet structures have large areas of delaminated concrete and spalls.
- There are substantial voids under the concrete apron of the outlet structure.
- The exposed concrete pipe supports are deteriorating.
- Concrete on the bridge abutments and center pier also needs to be replaced.
- The left conduit continues to slide down the slope.
- Concrete supports under the conduit are rotating because of ground movements relative to the pipe. As the supports tip they buckle the bottom of the pipe.
- Portions of the conduit continually need to be removed at the expansion/contraction joints to keep them functional. Additional lengths of conduit need to be added to replace displaced sections.
- Most of the expansion/contraction joints are leaking and have saturated the hillsides (see Figure 4.5.11).

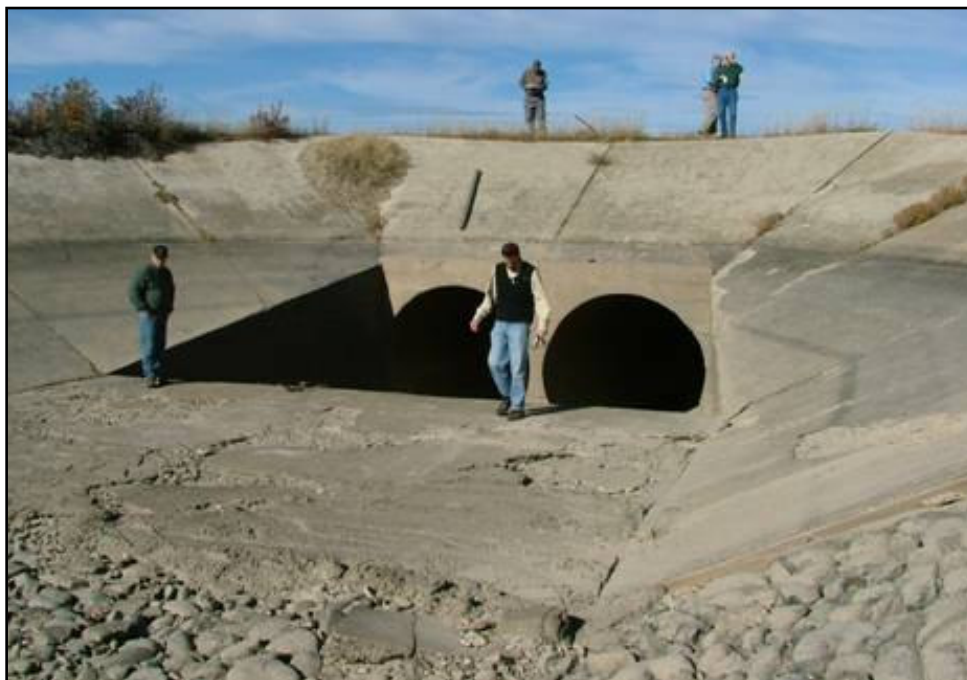
Figure 4.5.4 St. Mary River Siphon Outlet Structure (10/13/04).

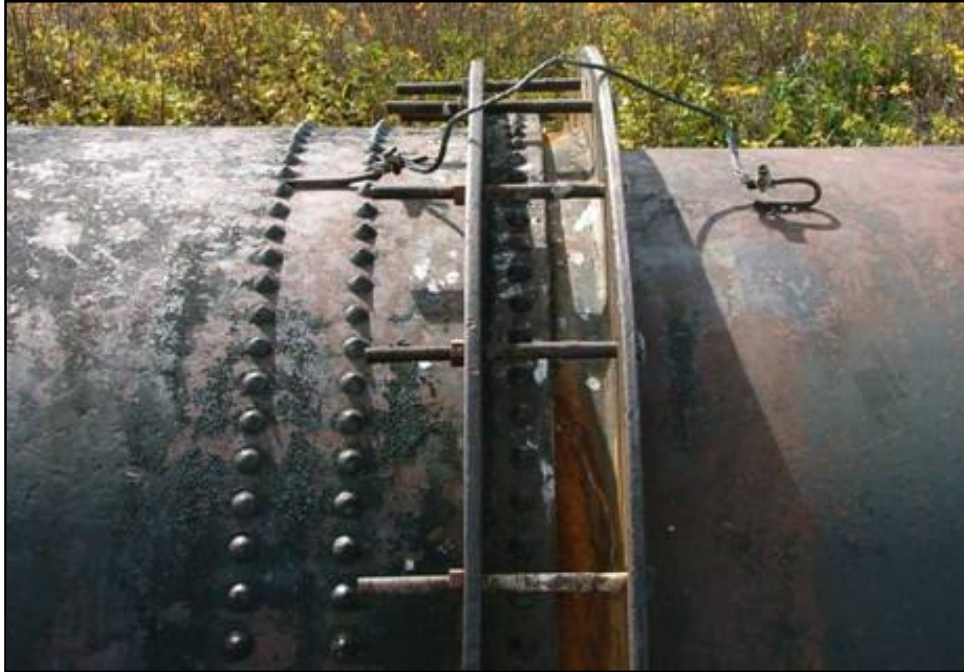
Figure 4.5.5 St. Mary River Siphon - Typical Expansion/Contraction Joint, Including Cathodic Protection Continuity Cable (10/26/04).

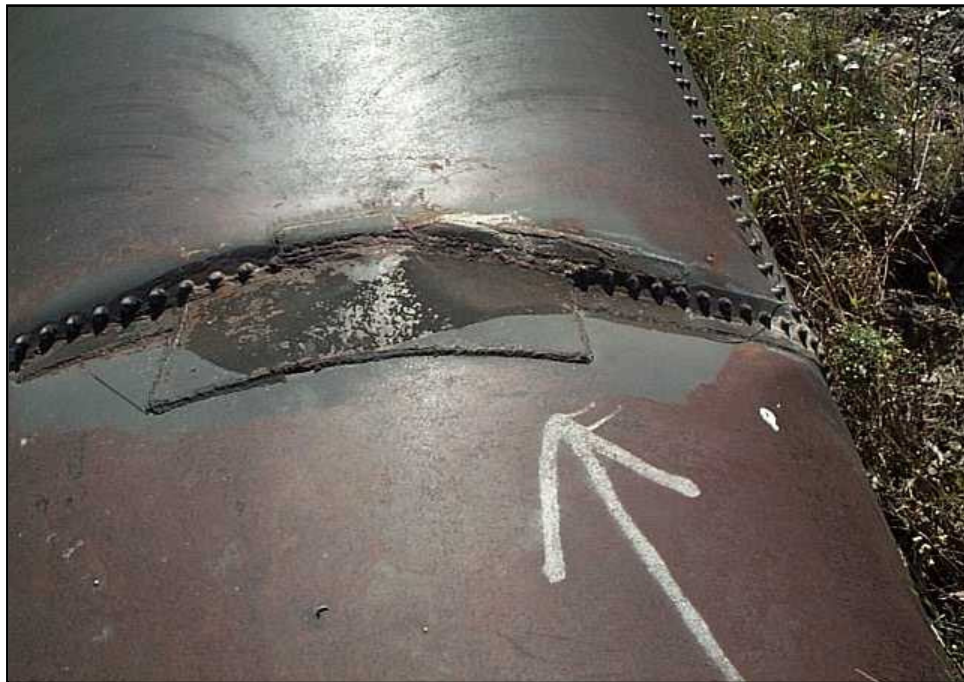
In 1954, a section of the left pipe was replaced and steel plates were installed where corrosion had damaged the steel. Figures 4.5.6 and 4.5.7 show typical siphon repairs due to deflection and corrosion. Also, there appeared to be seepage from the canal which moved along the siphon support foundation at both pipes. The left pipe was further unearthed and a perforated drain pipe installed, surrounded with well-graded gravel. One drain was installed on the north side of the left pipe, and one on the south side of the right pipe. A cathodic protection system was also installed on both pipes. This system remained in effect until 1997 when the pole support for the rectifier tipped over damaging the rectifier beyond repair.

Figure 4.5.6 Typical siphon repair due to deflection and/or corrosion (10/13/04).

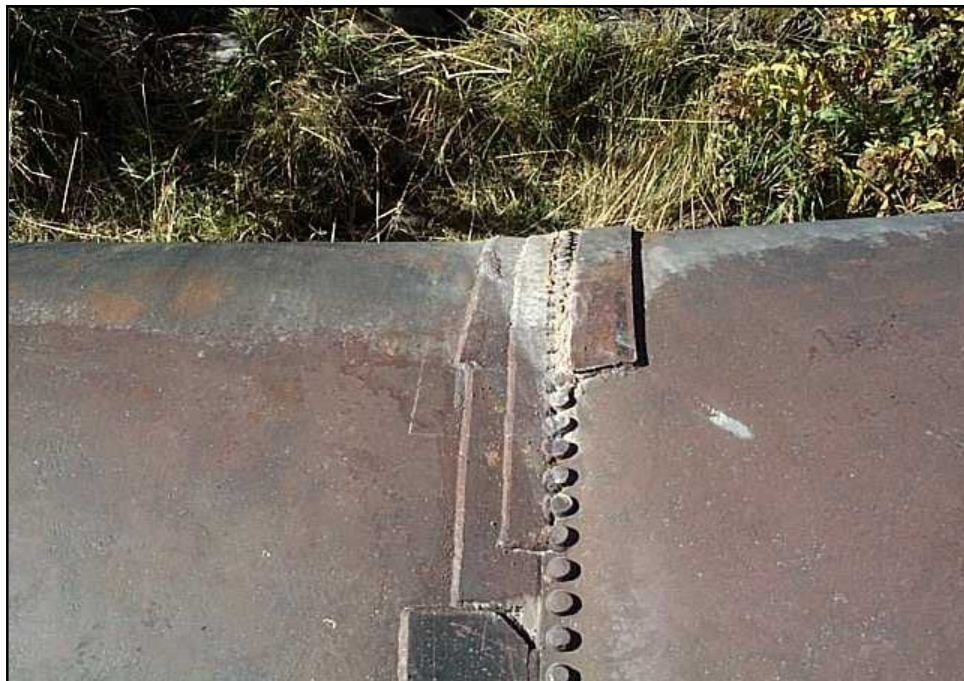
Figure 4.5.7 Typical siphon repair due to deflection and/or corrosion (10/13/04).

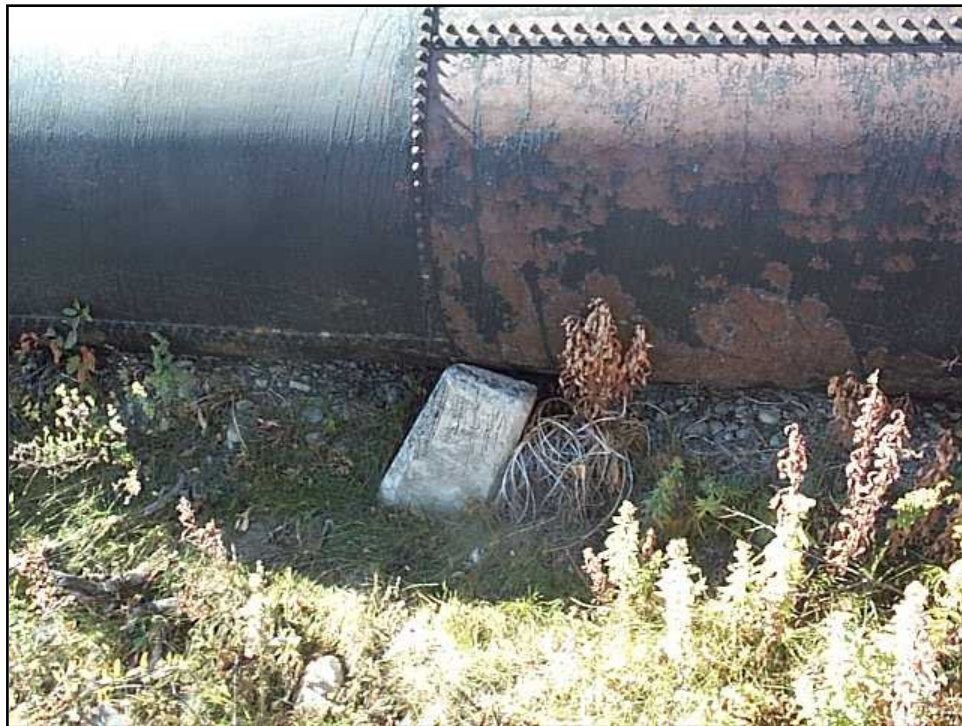
An inspection in the Fall of 1996 revealed complete closure of all the expansion joints in the left siphon, which resulted in compression buckling. This also caused the pipe supports to rotate downslope which created a point-load bearing condition. This resulted in up to 6-inch indentations in the pipe at the points of the concentrated load (Figure 4.5.8).

Figure 4.5.8 Photo shows ground movements right to left causing rotation of concrete support and point-loading of siphon which can lead to buckling (10/13/04).

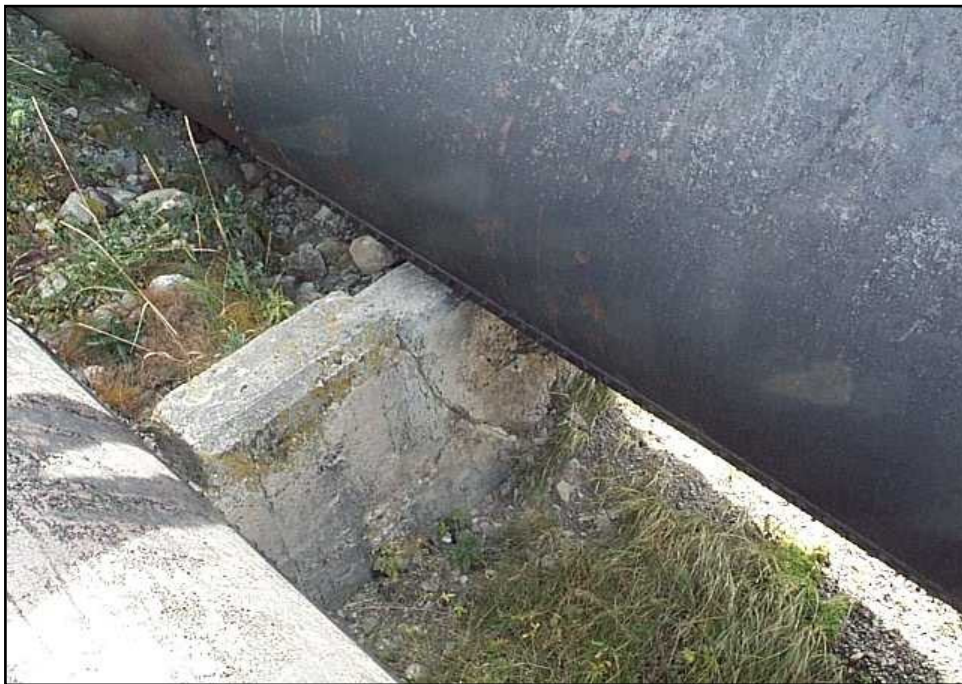
Figure 4.5.10 Photo shows concrete failure of a Halls Coulee Siphon support saddle (10/13/04).

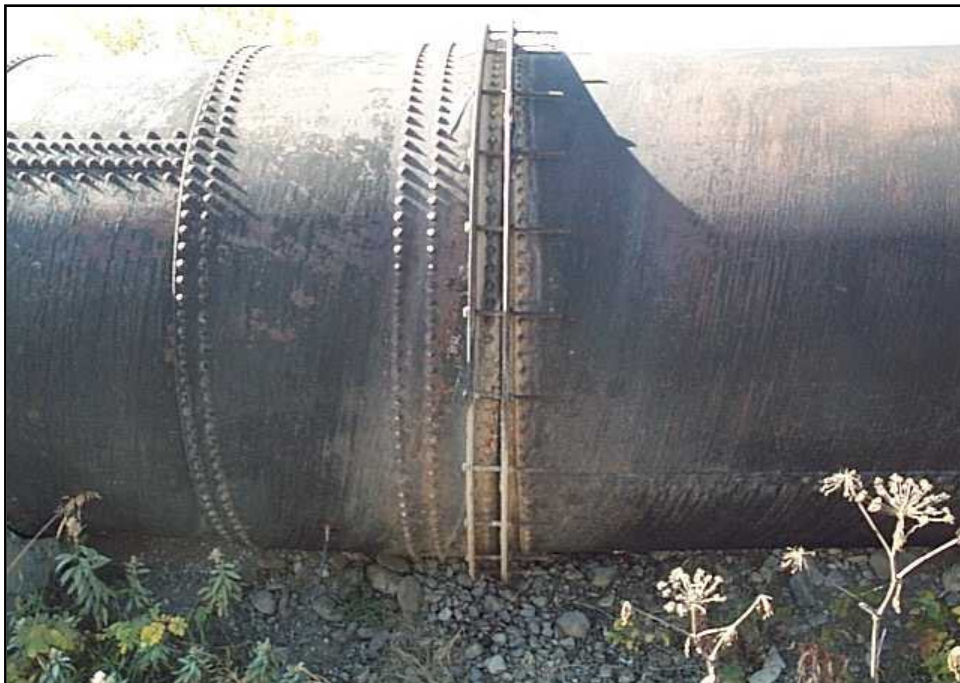
Figure 4.5.11 Leaking expansion/contraction joint on St. Mary River Siphon. Note erosion of supporting soil (10/13/04).

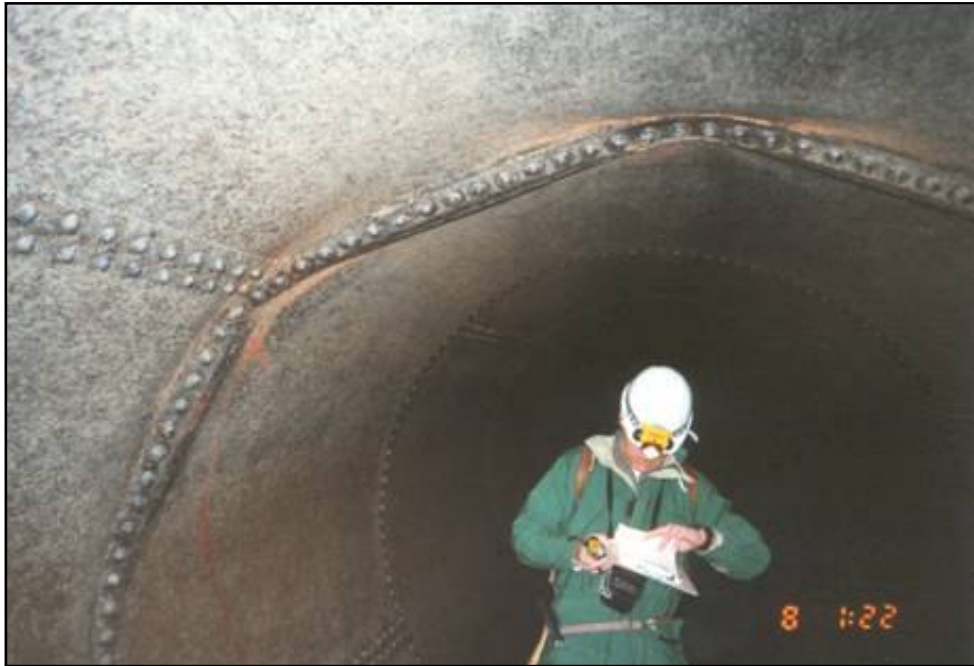
Figure 4.5.12 Typical Buckling at the Top of St. Mary River Siphon (10/26/04).

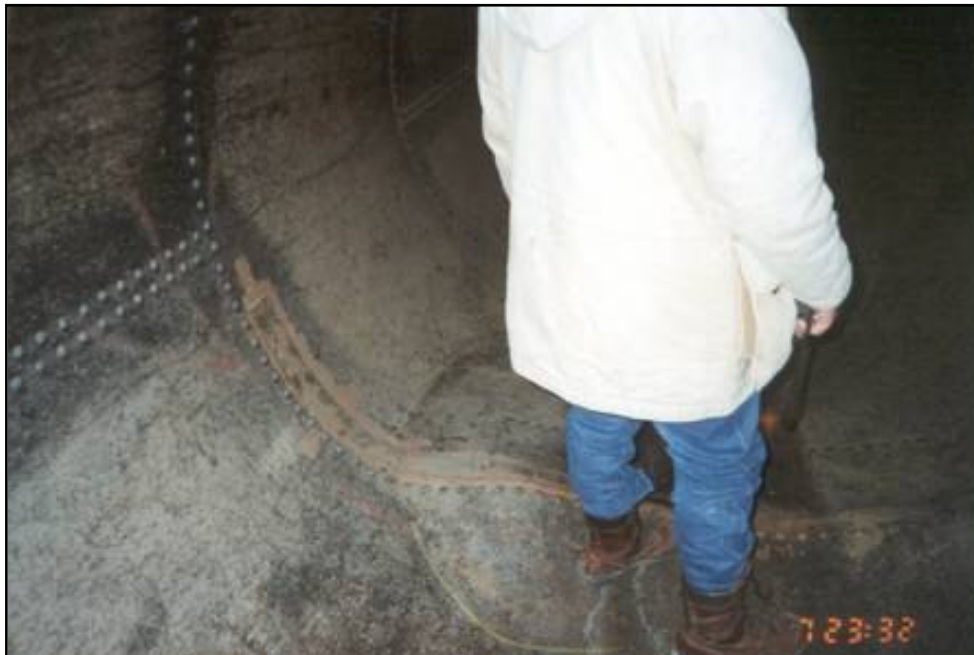
Figure 4.5.13 Typical Buckling at the Bottom of St. Mary River Siphon (10/26/04).

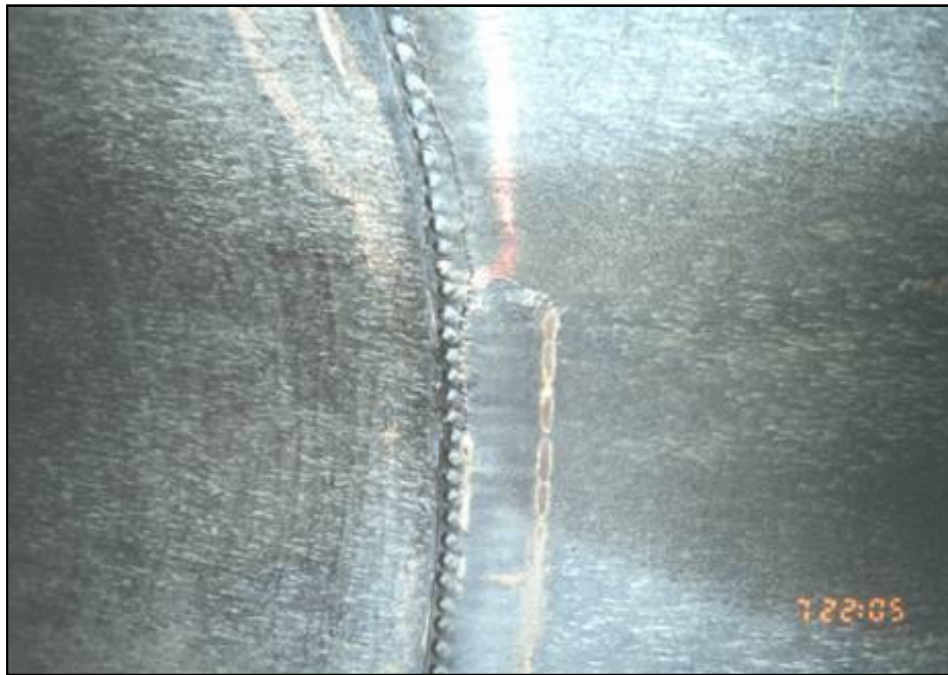
- Bolt heads are sticking up approximately 4 inches above siphon invert near the downstream end of the left siphon.
- The thinnest wall thickness was measured to be 0.23 inches.
- Circumferential cracks were noted in the steel of the right siphon, at Station 518+00. From the discussion at the site, it was understood that these cracks will be repaired prior to the next operating season.

Figure 4.5.14 Cracks in the Steel Near the Downstream End of the Right St. Mary River Siphon (10/26/04).

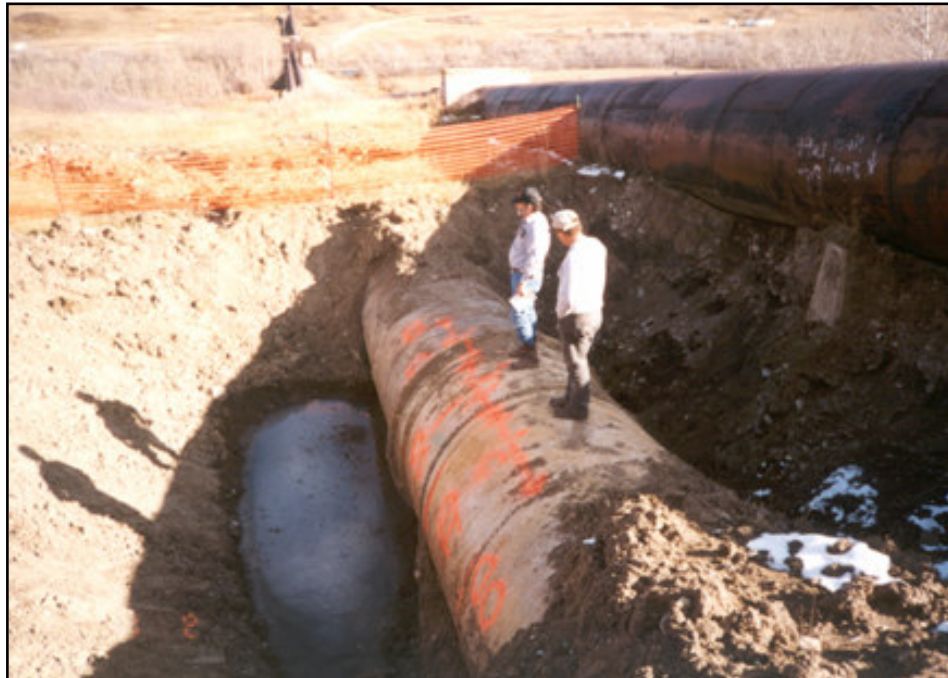
Figure 4.5.15 Exposed part of left siphon where expansion/contraction joint has closed. This joint was being replaced in the Fall 2004 (10/26/04).
